**DEPARTMENT OF TRANSPORTATION**

Contract #: 04-0120F4Cty: SF/Ala Rte: 80 PM: 13.2/13.9File #: 69.28**WELDING INSPECTION REPORT****Resident Engineer:**Siegenthaler, Peter**Address:** 333 Burma Road**City:** Oakland, CA 94607**Report No:** WIR-023132**Date Inspected:** 23-Apr-2011**Project Name:** SAS Superstructure**OSM Arrival Time:** 1900**Prime Contractor:** American Bridge/Fluor Enterprises, a JV**OSM Departure Time:** 700**Contractor:** Zhenhua Port Machinery Company, Ltd (ZPMC), Changxing Island **Location:** Shanghai, China**CWI Name:** See below**CWI Present:** Yes No**Inspected CWI report:** Yes No N/A**Rod Oven in Use:** Yes No N/A**Electrode to specification:** Yes No N/A**Weld Procedures Followed:** Yes No N/A**Qualified Welders:** Yes No N/A**Verified Joint Fit-up:** Yes No N/A**Approved Drawings:** Yes No N/A**Approved WPS:** Yes No N/A**Delayed / Cancelled:** Yes No N/A**Bridge No:** 34-0006**Component:** OBG and Tower Components**Summary of Items Observed:**

## WELDING INSPECTION REPORT

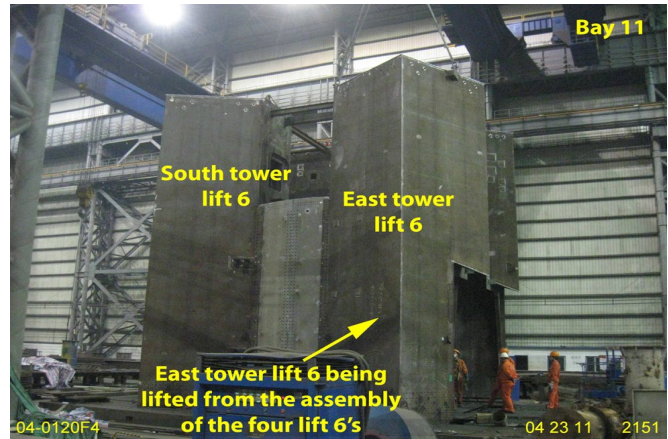
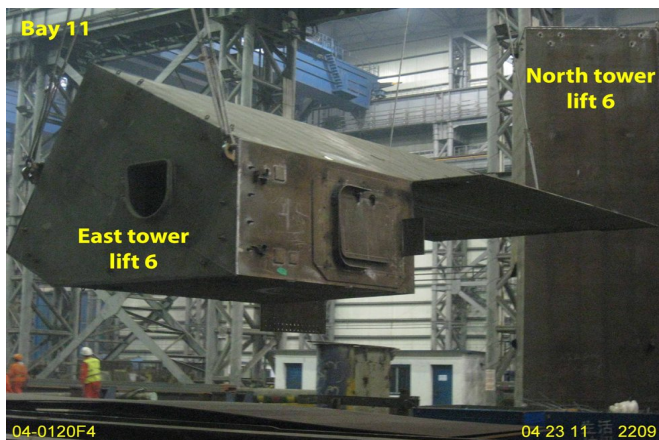
No welding related work was being performed. However, ZPMC workers lifted east tower, lift 6 away from the assembly of the four lift 6's, rotated it while suspended, and positioned it horizontally on stanchions. See photos below of East tower, lift 6 being lifted and rotated to a horizontal position using one overhead crane with two hooks.
